## Excavations at Fort Frederick, Kingston: Insights into the Design and Structural Development

Michael G. Berry

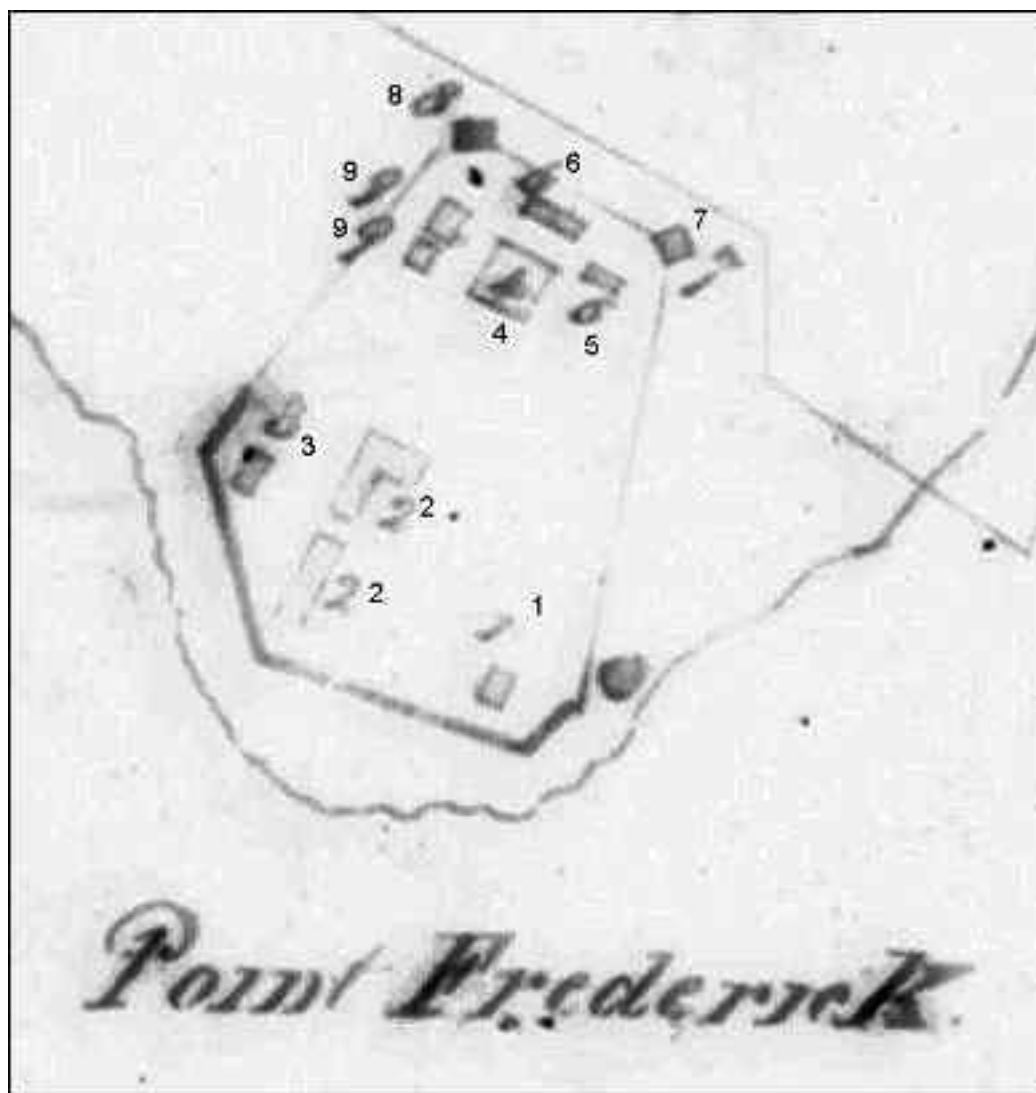
**Figure 2.** Detail of 1824 Board of Ordnance map of Fort Frederick (LAC NMC 16105): (1) Magazine, (2) Officers' Quarters, (3) Magazine, (4) Blockhouse, (5) Canteen, (6) Armourer's Shop, (7) Guardhouse, (8) Cookhouse, (9) Royal Artillery Barracks.

building phase at Fort Frederick. Upon the recommendation of Lieutenant Colonel Bruyères a *blockhouse* was constructed in December of 1812. Measuring 48 feet square around the lower storey (Young 1980:49), the blockhouse was constructed with the intent of housing four officers and 140 men (Young 1980:79). Additional buildings mentioned through archival sources as being constructed during the War of 1812 include officers' quarters, Royal Artillery *barracks*, log barracks, *guardhouse*, *canteen*, *armourer's shop* and *powder magazine* (Bazely 1995) (Figure 2).

The 1831 map has two main differences from the 1824 plan that help to identify the function of the structure recovered. Firstly, the building identified in 1824 as the second officers' barracks (Figure 2, #2) is described as the canteen and barrack master stores. The description for this building in 1831 is as follows:

It remains an easy assumption that the function of this building changed some time between 1824 and 1831. The second difference is that the structures identified in 1824 as the canteen and the armourer's shop are no longer present (Figure 2, #5, #6). One structure is identified as "ruin" in the area of the former canteen. By using the dimensions of known buildings on the 1831 map as a basis of comparison, the length of the "ruin" can be calculated to be approximately 9.14 m by 3.66 m (30 feet by 12 feet). This most closely matches the dimensions of the canteen at 7.32 m by 3.05 m (24 by 10 feet) and is likely what this "ruin" and the

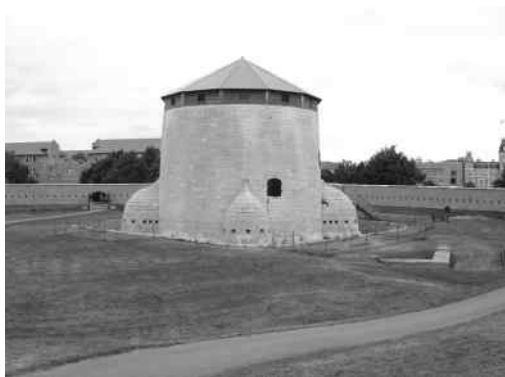
**Figure 3.** *The modern site of Fort Frederick. Note exposed southeast corner of the 1812 blockhouse in lower right (Cataraqui Archaeological Research Foundation).*

In the late 1830s, following the construction of the Rideau Canal and revived tensions with the Americans, the need for a new fort was deemed necessary. The requirement for greater defences was solidified when another threat of war with the Americans grew out of the Oregon Crisis. This threat led to the construction of four *Martello towers* between 1846 and 1848. These were situated on Murney Point with Murney Tower, the shoal in front of City Hall with Shoal Tower, on Cedar Island with Cathcart Tower, and the largest built on Point Frederick named Fort Frederick. The construction of the Fort Frederick tower required a complete destruction and re-landscaping of the previous fort in order to create a new earthworks and battery. As previously mentioned, the grounds exist more or less in this form to this day (Figure 3).

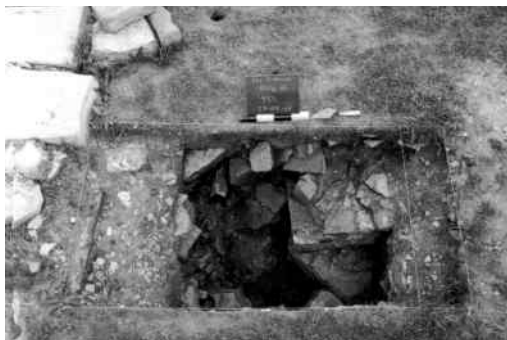
**Figure 5.** Planview photograph of 48N showing the Royal Artillery barracks foundation wall (right) and rubble fill (left) (Cataraqui Archaeological Research Foundation).

removed in order to build the Martello tower. Finds within 48N showed a large trench area that cut through the 1812 structure and through the existing bedrock. Rubble fill remains from within the Royal Artillery barracks were found sloping out and down through the trench cut (Figure 5). A thick clean clay deposit also capped this fill. This suggests that the barracks were destroyed not very long before the construction of the Tower, and that it was necessary to stabilize the spilling of incompact destruction debris out of the remains of the Royal Artillery barracks. The destruction debris from the barracks was rich with cultural material. One of the interesting finds was a button of the 68<sup>th</sup> Regiment of Foot. Known as the Durham Light Infantry, the Regiment was posted at Fort Frederick between May of 1820 and May 23, 1823 (Stewart 1964:283).
